Second Generation Camaro Owners Group - Camaro Rear Axle Information & Restoration

This section contains information related to the identification, description and restoration of the rear axle on the Second Generation Camaro.

Camaro Rear Axle Information

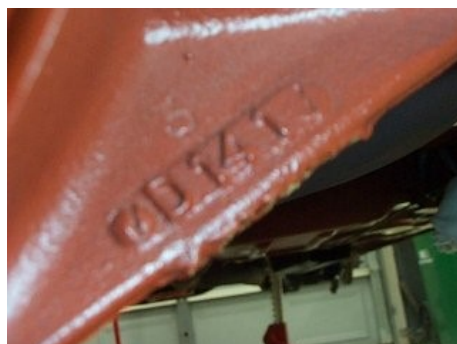
8.2" 10 bolt			8.5" "Corporate"			12 bolt		
Casting #	Series	Gearing	Casting #	Series	Gearing	Casting #	Series	Gearing
ED32118	2	2.73:1 & down	410408N	3	2.73:1 & up	ED32088	2	2.73:1 & down
EDB30116	3	3.08:1 & up	410409N	2	2.56:1 & down	30140PM1	3	3.08:1 to 3.73:1
						EDB30174	4	3.90:1 & up

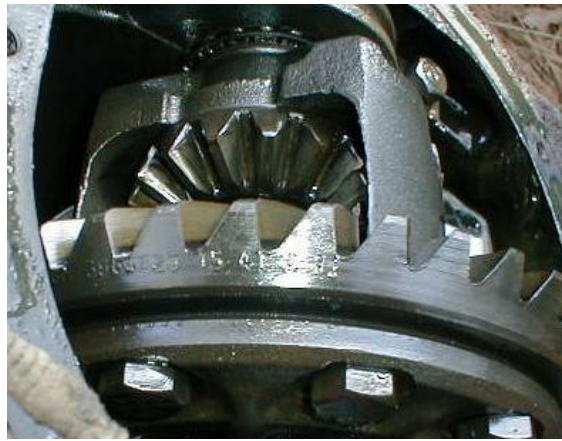
Abey photo: Notice the "15 41" on the ring gear - this rear end is a 2.73 ratio.

2.56:1	41,16
2.73:1	41,15
3.07:1	43,14
3.08:1	40,13
3.08:1	37,12
3.31:1	43,13
3.36:1	37,11
3.42:1	41,12

3.73:1	41,11
4.10:1	41,10
4.11:1	37,9

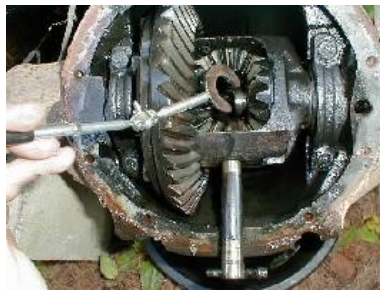
It's not necessary to remove the rear end in order to repair it. It does make it easier to clean and paint if it's removed, but this is up to you. You'll need a slide-hammer for this job too.

Remove the cover & drain the fluid. Inspect the gears for wear & damage. Pull the axles and inspect. Remove brakes. Use slide hammer to remove seals & bearings. Replace seals & bearings. Reinstall axles. Fill rear end with quality fluid, including posi-supplement if this is a posi rear end.
